**EL 1165A DRILLING DISCHARGES FOLLOW-UP PROGRAM: DRILL  
CUTTINGS MEASUREMENTS AND MONITORING 2020 REPORT**

**ExxonMobil Canada Ltd.**

**Wood Environment & Infrastructure Solutions,  
a Division of Wood Canada Limited**

23 February 2021

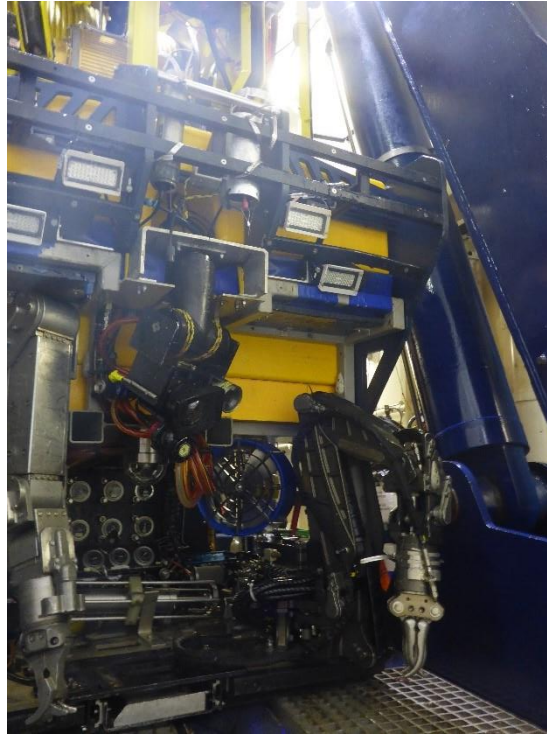
**Figure 2-1 Millennium 191 ROV used for the 2018 and 2020 EL 1165A post-drilling survey.**

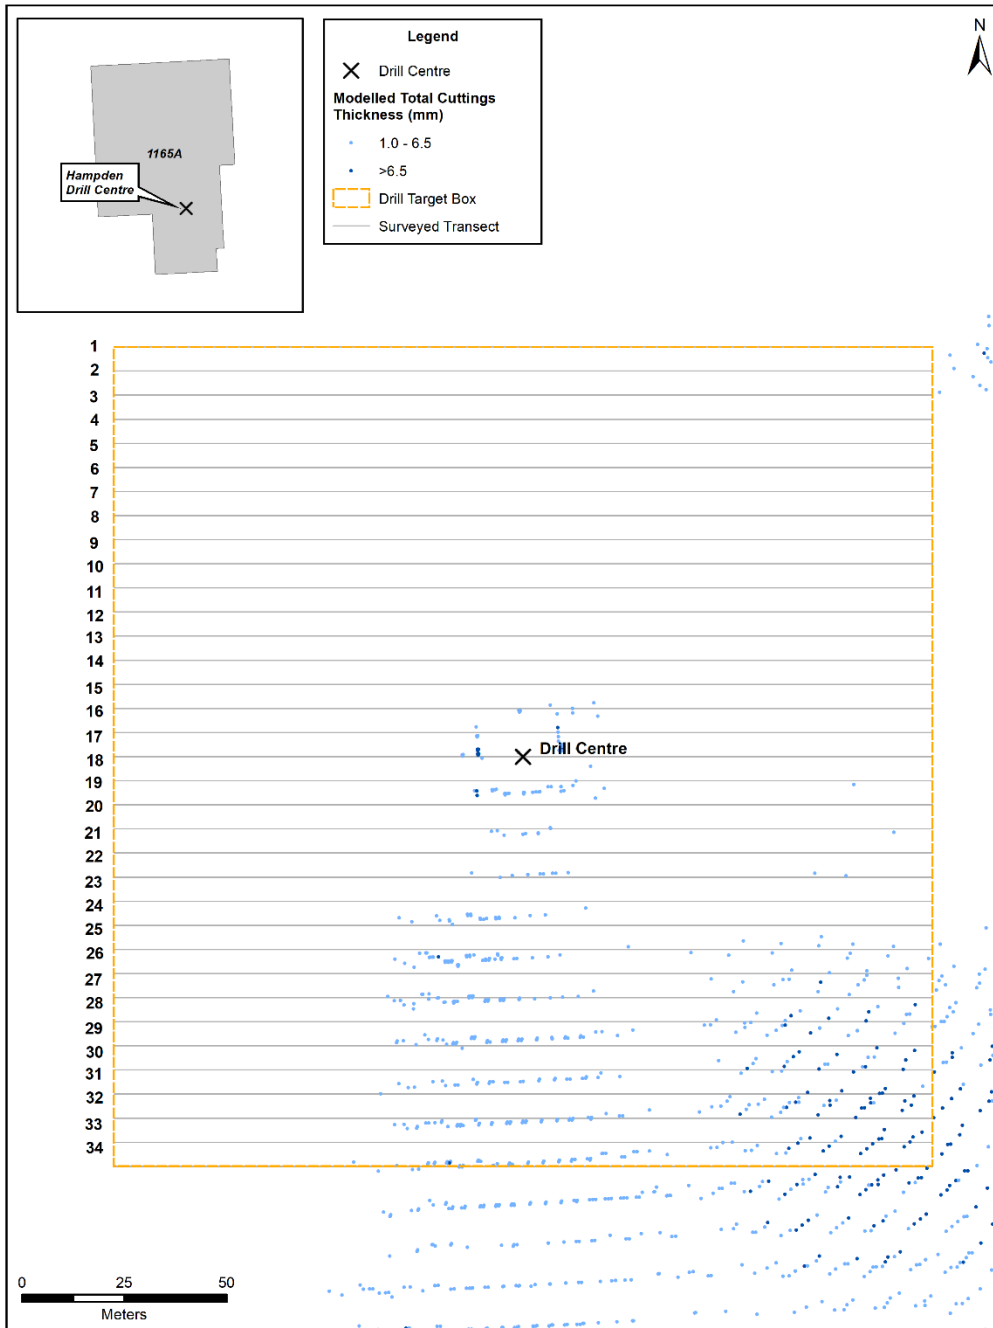
**Figure 2-2 Post-drilling survey design at EL1165A.**

Similar to the 2018 baseline survey, the survey consisted of a 200 m by 200 m grid composed of 34 horizontal surveys lines (running east to west) spaced 6 m apart centered around the wellhead (Figure 2-2). The ROV operated in two modes: survey and sampling (measuring). Survey mode was used to describe the characteristics and extent of the drill cutting footprint and sampling mode was where the ROV took physical measurements of the seafloor with a ruler.

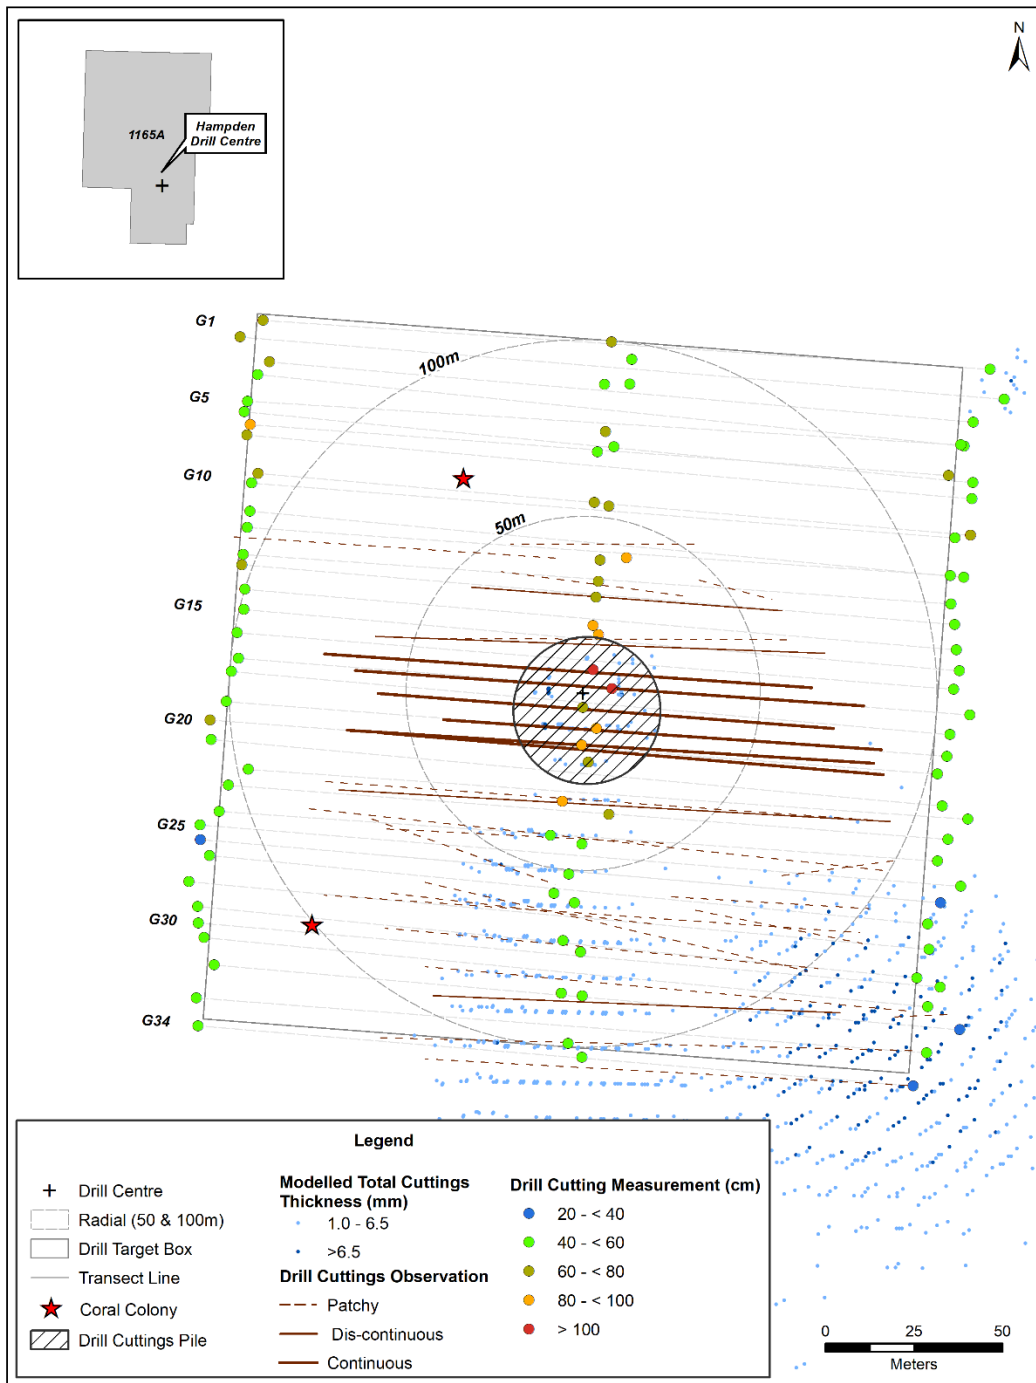
Drill cuttings were visibly distinct from seafloor sediments in color, texture, and particle size. Two types of drill cuttings were observed within the survey area pile cuttings and fine-grained cuttings. The pile cuttings consisted of loosely condensed white clumps (Figure 3-3, B to D). These cuttings were easily disturbed by the ROV and the clumps remained intact as they rolled across the seafloor. Fine-grained drill cuttings were dense and did not easily disperse in the water column. When touched by the ruler, the cuttings had a dense viscous consistency that stayed close to the seafloor (Figure 3-3, F). Drill cuttings were observed in three types of distributions (Figure 3-2):

There was a concentration of drill cuttings  $<50$  m radius around the well head with cuttings  $> 50$  m were mostly observed to the south and southeast of the drill center, a direction consistent with predictions from the drill cuttings dispersion model (Figure 3-2). Visibly distinct drill cuttings were observed in various distribution types starting along transect G-10 to G-34. The drill cuttings model depicted in Figure 3-2 shows the predicted dispersion of both WBM and SBM although only WBM were used for this drilling campaign.

**Figure 3-2 Distribution of drill cutting observations in relation to the drill center and the predicted drill cutting footprint and sediment penetration measurements.**

Visibly distinct drill cuttings were observed in various distribution types within 50 m of the wellhead from transect G-10 to G-26 (Figure 3-2). Patchy drill cutting distributions were noted from G-10 to G-12 and G14. The drill cutting pile was centered around the wellhead on transect G17 and extended into transects G16 and G18 to G20 (Figure 3-2). Based on measurements of known structure sizes of the wellhead and distances to the seafloor, drill cutting deposition was approximately 300 cm high at the wellhead. Sediment measurements taken within the drill cutting pile (Figure 3-4 A&B) ranged between 75 to >100 cm (the length of the ruler was 100 cm) (Appendix B, Table B 1). Measurements taken along the center of each gridline are presented in Figure 3-5. While both drill cutting and natural sedimentation could not be distinguished from the single measurement at each location, there is a notable increase in penetration within 50 m of the wellhead with the deepest penetrations occurring in drill cuttings pile. Measurements in the fine-grained drill cuttings adjacent to the drill cuttings pile ranged in depth from 70 to 95 cm and there is a noticeable decrease after transect G-23. Based on these observations, measurements > 80cm appear to be related to drill mud accumulations and sediment accumulations on the order of 10s of cm appear to be restricted between G13 to G21. While benthic invertebrates were absent from the drill cuttings pile, there were corals (sea pens) present on the fine-grained drill cuttings adjacent to the pile. Other pelagic fauna including blue hake were present (Figure 3-3, B).
